Project Name: Gold King Mine	Site Location: Silverton, San Juan County, Colorado	Project No. 0001/1408-01
--	---	------------------------------------

PHOTOGRAPH LOG

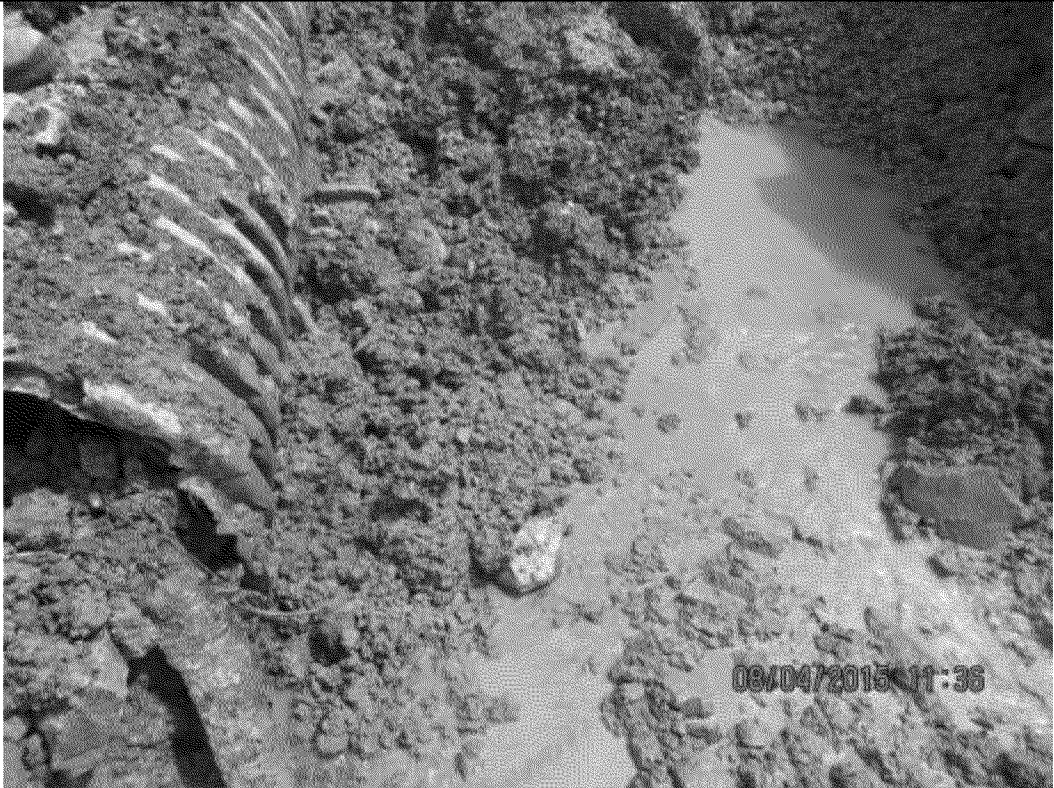
<p>Photo No. 3</p>	<p>Date: 08/04/2015</p>

<p>Direction Photo Taken:</p> <p>Down</p>		
<p>Description: Seepage from soil next to piping.</p>		
<p>Photo No. 4</p>	<p>Date: 08/04/2015</p>

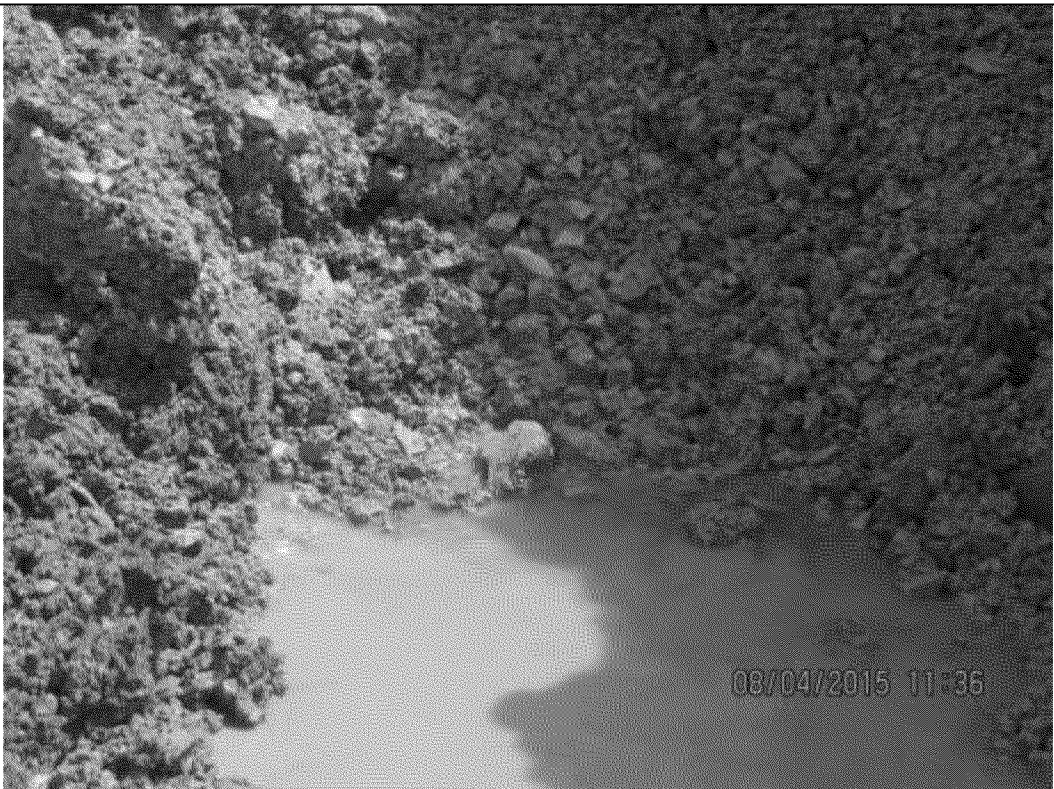
<p>Direction Photo Taken:</p> <p>Down</p>		
<p>Description: Seepage next to the pipe is clear until entering disturbed soil.</p>

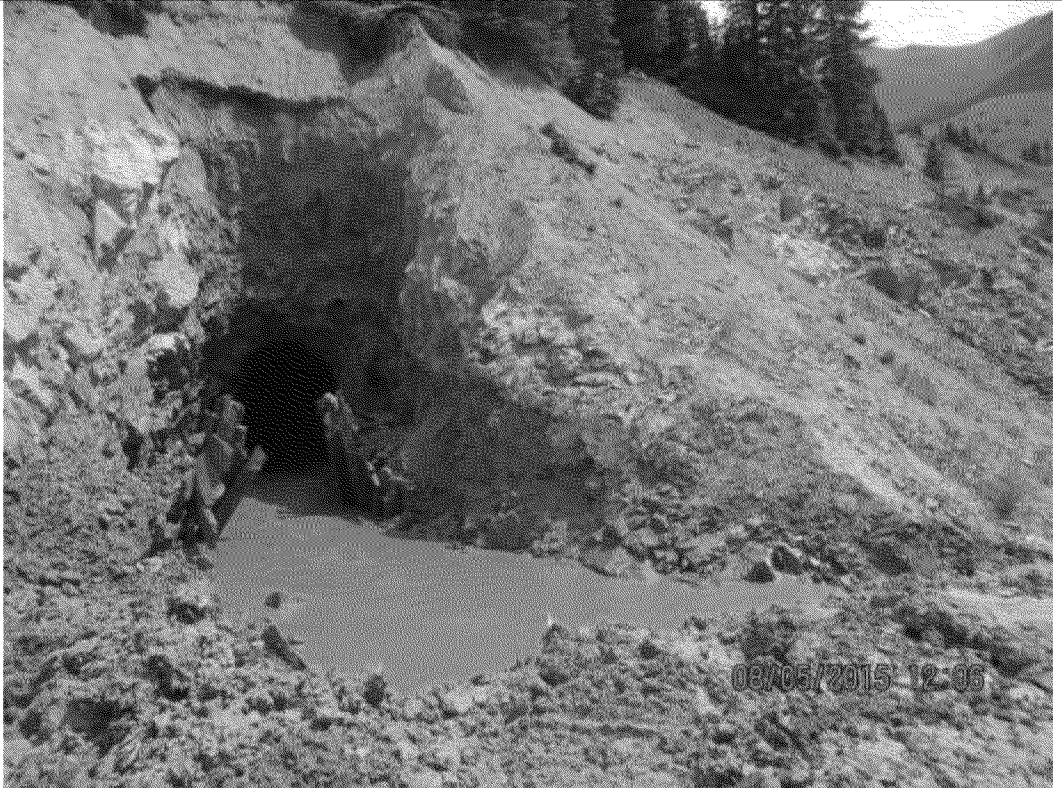
Direction Photo Taken: North		
Description: Exposed adit and redirected flow, flow is beginning to subside.

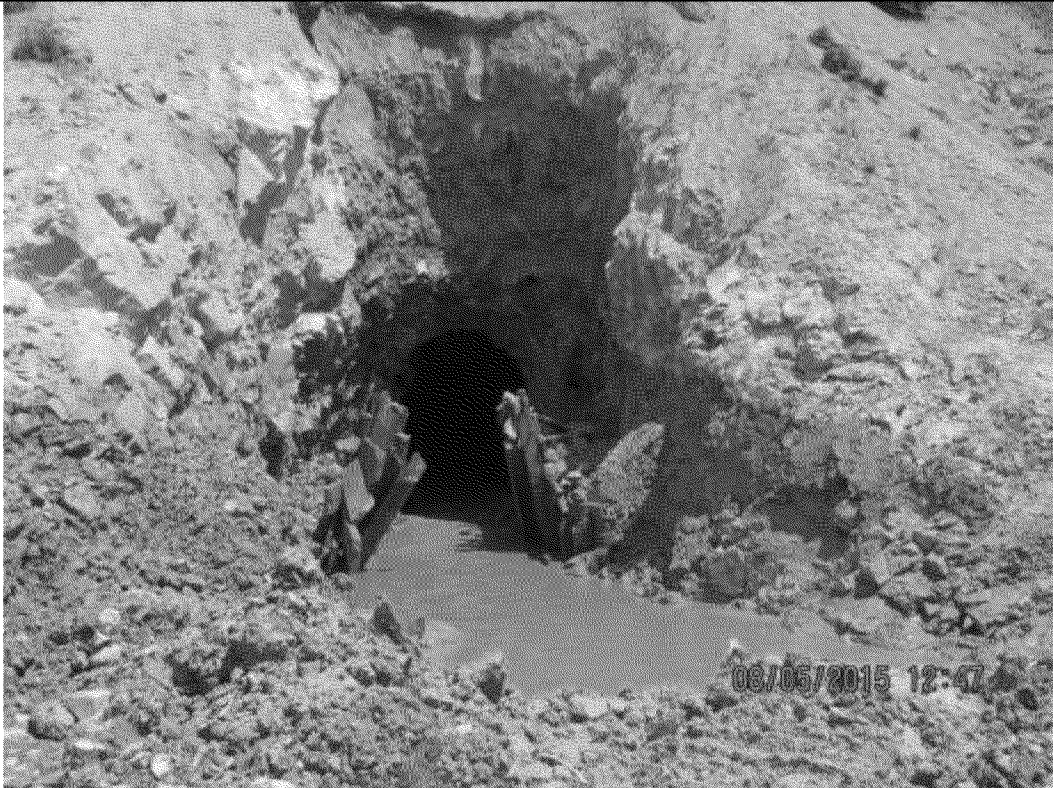
Photo No. 39	Date: 08/05/2015

Direction Photo Taken: North		
Description: No changes visible in adit structure or supports. Sloughing of materials inside the mine can be heard.		
Photo No. 40	Date: 08/05/2015

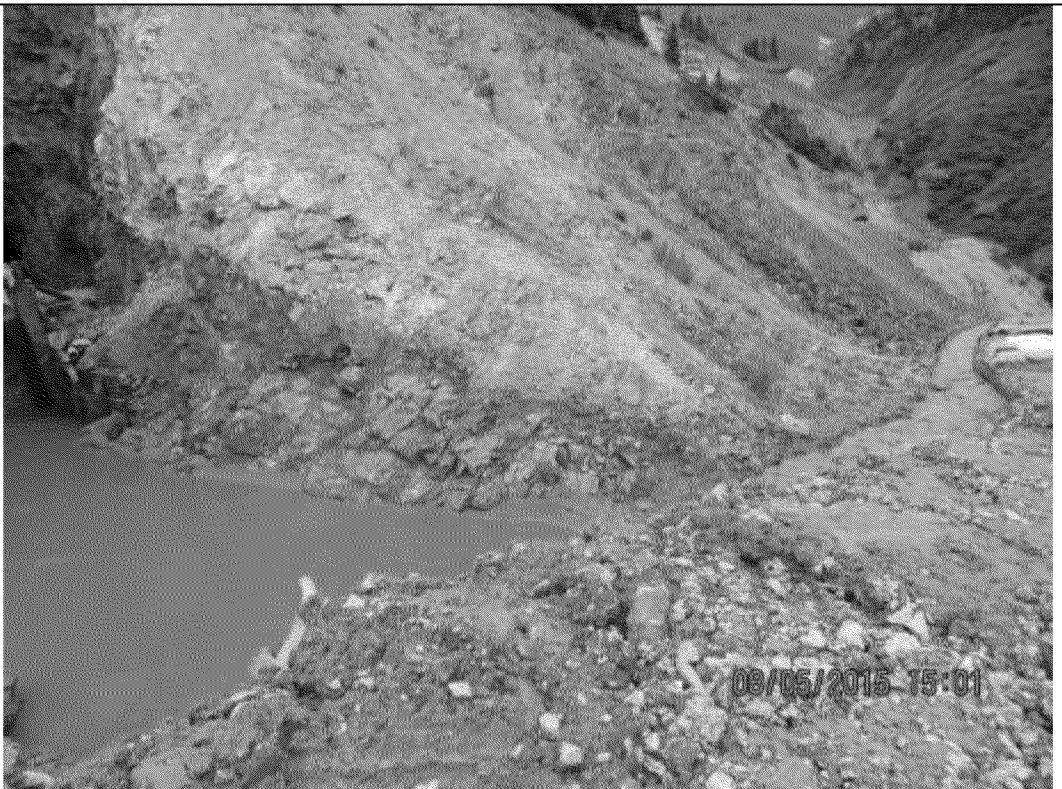
Direction Photo Taken: Northeast		
Description: Flow path from adit, water flow appears to have stabilized around 1400.

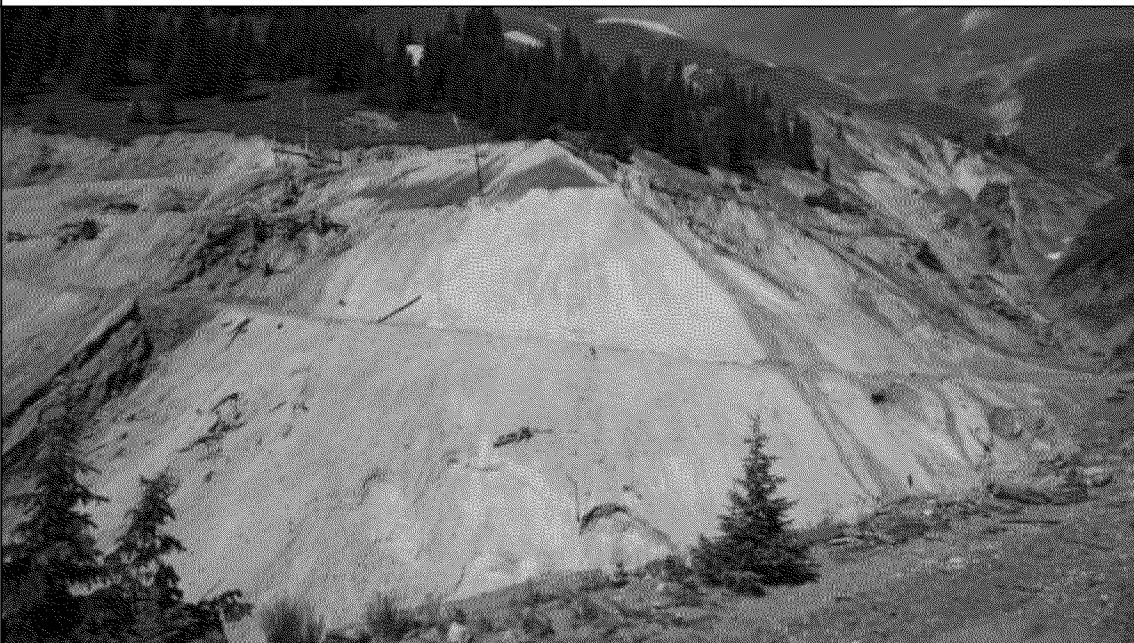
Direction Photo Taken: Northeast		
Description: Gold King Mine tailings dump after water discharge.
